Manhole Inspection Summary

Manhole # S2900_033MH

Location Address: **2601 FALLS RD**

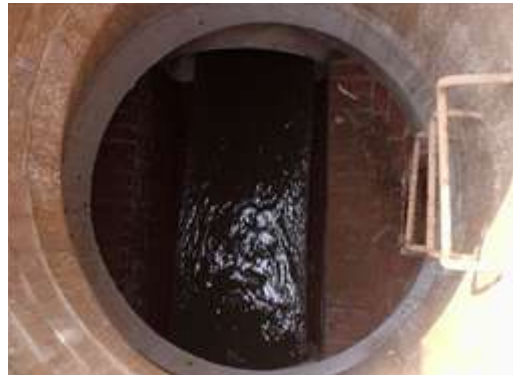
Top View

Bench debris.

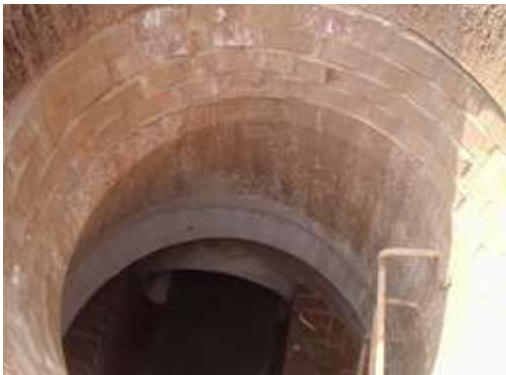
Defect

Frame Offset: **0** (in.) Condition: ☐ Sound ☐ Cracked ☒ **Leaks**

Infiltration: ☐ None ☒ **Joint** ☐ Cracks ☐ Mortar ☐ Roots ☐ Wall

Infiltration: ☐ None ☒ **Joint** ☐ Cracks ☐ Mortar ☐ Roots ☒ **Wall**

Frame leaks. Adjustment and Corbel infiltration - other side.

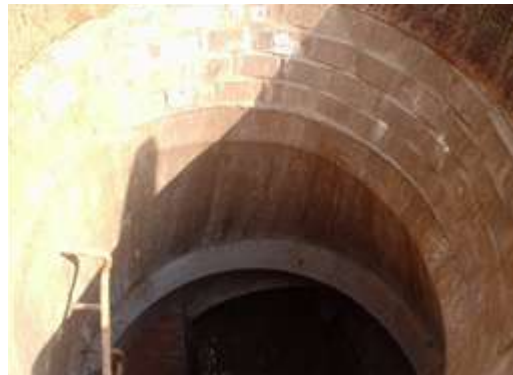
Defect

Frame leaks. Adjustment and Corbel infiltration.

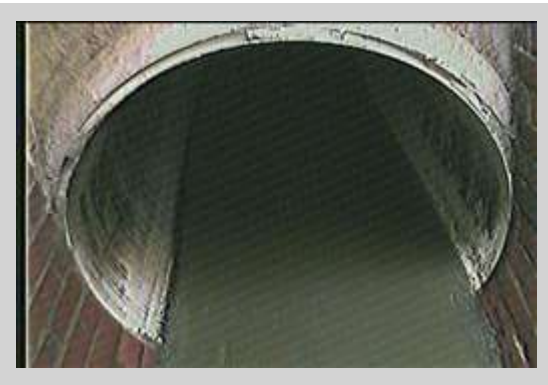
36 in. Circular Gravity Sewer Pipe Out @ 12 O'Clock

☒ Pipe Lined

Infiltration: **None**

Pipe Seal Cond: **Sound**

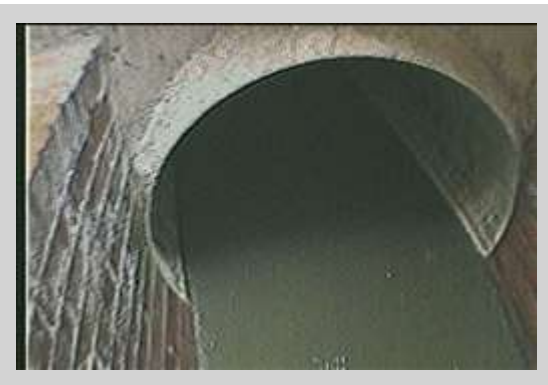
36 in. Circular Gravity Sewer Pipe In @ 6 O'Clock

☒ Pipe Lined

Infiltration: **None**

Pipe Seal Cond: **Unknown**
